# FIRST QUALITY SOLUTIONS

## ULTRASONIC THICKNESS EXAMINATION REPORT

Sample Waterwall Report  
 Furnace Waterwall Ultrasonic Thickness Inspection  
 Nov 2010 Outage

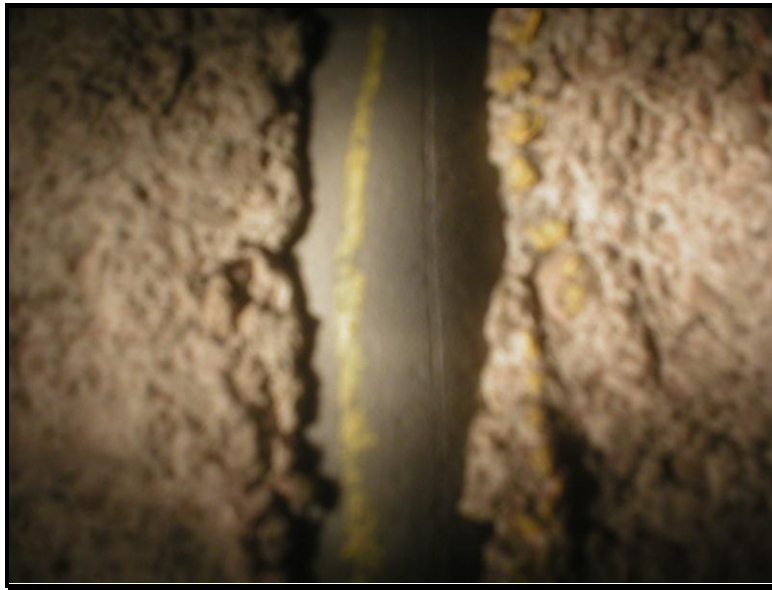
1. Elev. 675, cracking on the front wall header tube stub at the front wall header, tube # 29.

- Perform ultrasonic thickness testing at approximately the same elevations as this outage during the next scheduled maintenance outage.
- Restore all areas where walls have been bowed.
- Replace all tubes where pad welds were found from past repairs.

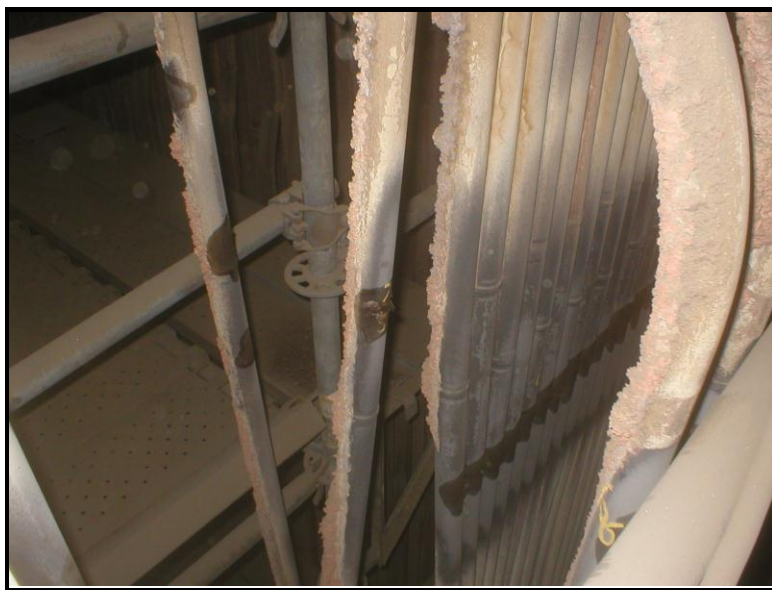
2. Elev. 675, division wall tube # 75 bent out of plain.
