# FIRST QUALITY SOLUTIONS

## ULTRASONIC THICKNESS EXAMINATION REPORT

Sample Waterwall Report  
 Furnace Waterwall Ultrasonic Thickness Inspection  
 Nov 2010 Outage

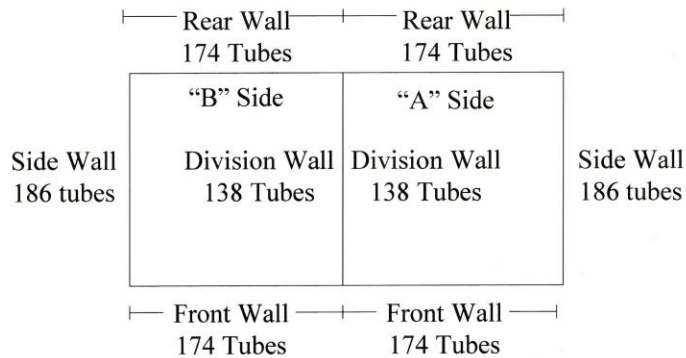
The furnace is divided into two cells by a division wall; each cell was regarded as its own unit. The front and rear walls have 174 tubes, the sidewalls have 186 tubes, and the division wall has 138 tubes. A mapping of the waterwall layout can be seen below.
